This Day in History... February 5, 1935

The Electric-Eye Perforator

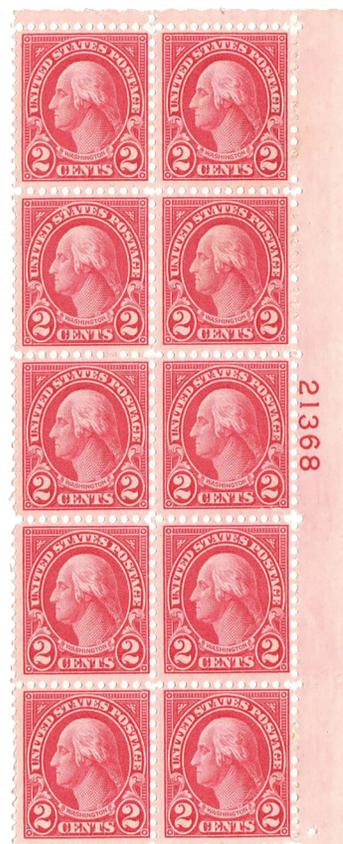
Plate block of 10 2¢ Washington stamps from one of the first runs of the electric eye perforator.

The perforations produced with the electric eye machine were the same as previous stamps and the gauges were the same. However, the plates used to print the stamps were changed. They now had thick dashes that were $\frac{3}{8}$ of an inch long and $\frac{1}{4}$ of an inch apart, which the Bureau referred to as “register marks.” The machine’s “electric eye” scanned these dashes, and the machine used a series of gears and motors to move the paper forward, backward, left, or right, to ensure near perfect centering.

The first electric eye perforator had three photoelectric cells to monitor these markings. Two cells were positioned to monitor the vertical dashes in the center gutter. A third photoelectric cell was positioned over the single horizontal mark “guide dash” that was printed in the right margin between the upper and lower panes. This cell was used to ensure the proper alignment of the pairs of pins that created the horizontal perforations. It also set the speed with which the web of paper traveled through the perforator. It was because of the location of this cell and its corresponding mark that the stamp plate numbers were moved from their usual positions to the ends of the third row of stamps from the top or bottom of the sheet.

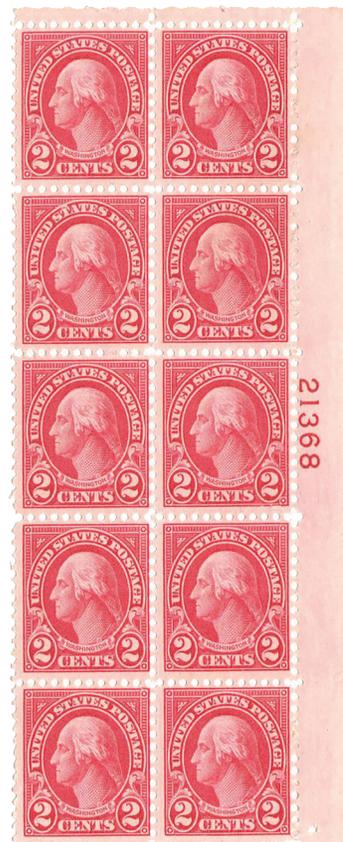
Plate block of 10 2¢ Washington stamps from one of the first runs of the electric eye perforator.

The perforations produced with the electric eye machine were the same as previous stamps and the gauges were the same. However, the plates used to print the stamps were changed. They now had thick dashes that were $\frac{3}{8}$ of an inch long and $\frac{1}{4}$ of an inch apart, which the Bureau referred to as “register marks.” The machine’s “electric eye” scanned these dashes, and the machine used a series of gears and motors to move the paper forward, backward, left, or right, to ensure near perfect centering.

The first electric eye perforator had three photoelectric cells to monitor these markings. Two cells were positioned to monitor the vertical dashes in the center gutter. A third photoelectric cell was positioned over the single horizontal mark “guide dash” that was printed in the right margin between the upper and lower panes. This cell was used to ensure the proper alignment of the pairs of pins that created the horizontal perforations. It also set the speed with which the web of paper traveled through the perforator. It was because of the location of this cell and its corresponding mark that the stamp plate numbers were moved from their usual positions to the ends of the third row of stamps from the top or bottom of the sheet.
